QAR Inspection Dive - August 18, 2004

Chris Southerly 08/20/04

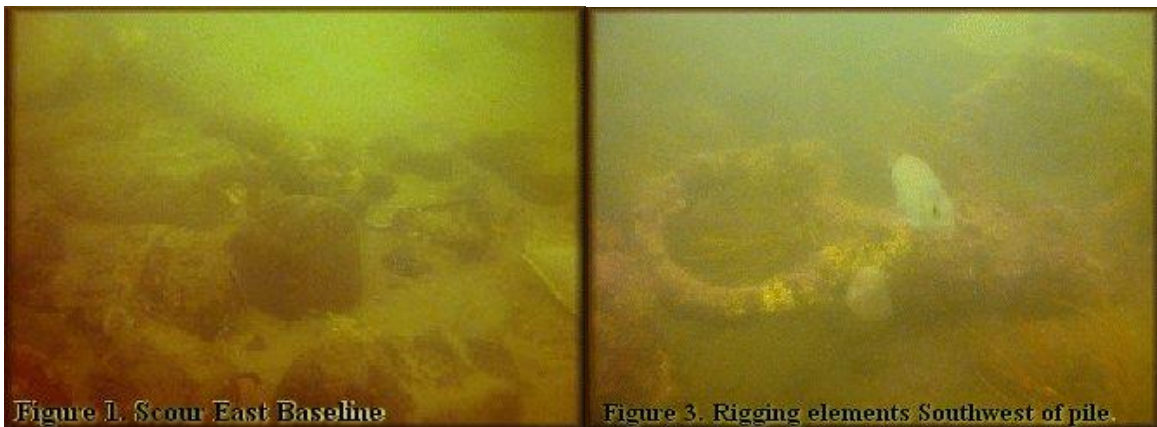
The site area shows evidence of scour around the main pile. Ballast and concretions east of the baseline between 70 and 80 north are again exposed, not seen since after Hurricane Isabel in September 2003. (Figure 1). Cannon C-1 is very exposed, almost completely above the surrounding sand (Figure 2). Cask hoops and rigging elements to the southwest side of the pile were also exposed more than previously observed. (Figure 3). Sacrificial planking at the south edge of the pile that is normally buried was easily visible extending up to 5 feet south covered only with a light dusting of sand. (Figure 4). Sandbags could be seen along the north side of the pile at the edge of past excavation areas and along the east side. (Figure 5). Anchor A-1 was exposed completely down to the ring and anchor A-3 was exposed almost to the stock. Part of the wooden stock of anchor A-3 was also exposed just to the north of the anchor. The area south of BL60 was still sanded in.

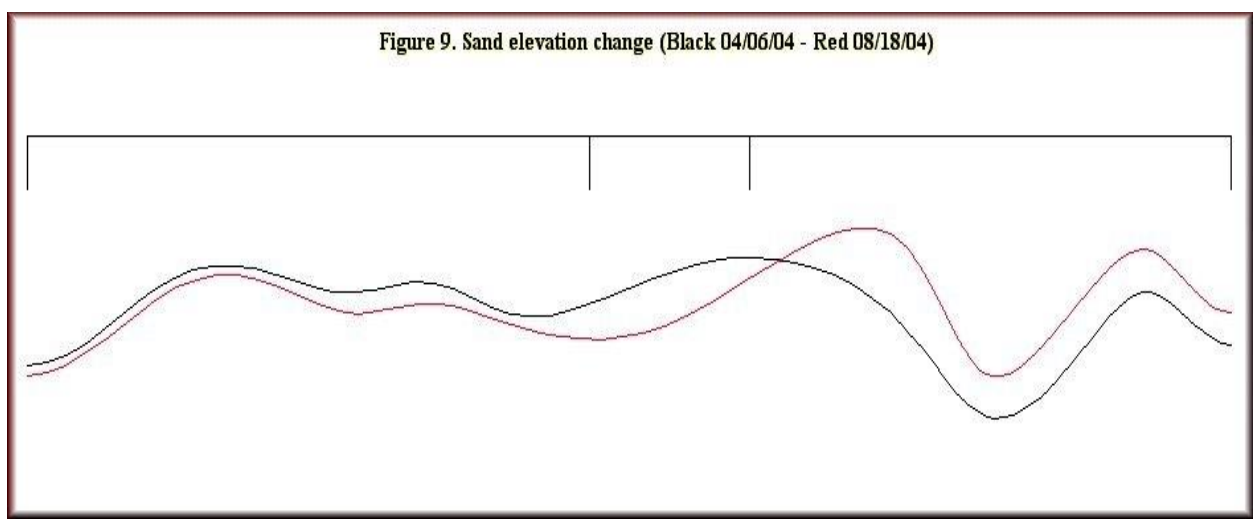
Figure 9. Sand elevation change (Black 04/06/04 - Red 08/18/04)

The buoy was thrown on the pile coordinates, and RWL entered the water with a mooring buoy. Once RWL located the site, the mooring line was fastened to the east screw-eye and R/V Snap Dragon secured to the mooring. RWL proceeded with general recon and site cleanup. NCH entered the water with the digital camera to do general recon and document conditions and site exposure. Once RWL returned, CWS entered the water to take sand elevations and conduct a visual recon (Figure 6). JGB also conducted a site reconnaissance and as the last diver in the water, retrieved the buoy and released the mooring line from the east screw-eye. A single fragment of stoneware found near the exposed planking south of the pile was recovered because of the likelihood of it being lost (Figures 7, 8). Detailed sand measurements show a deposition of sand to the north area of the site, scour in the immediate vicinity of the pile (especially to the east and south), and a slight sand loss to the south area of the site (Figure 9).
