NORTH CAROLINA OFFICE OF STATE ARCHAEOLOGY

FALL 2015 FIELD REPORT FOR ARCHAEOLOGICAL SITE 31CR314, *QUEEN ANNE'S REVENGE*

QAR TECHNICAL REPORT SERIES

QAR-R-17-01

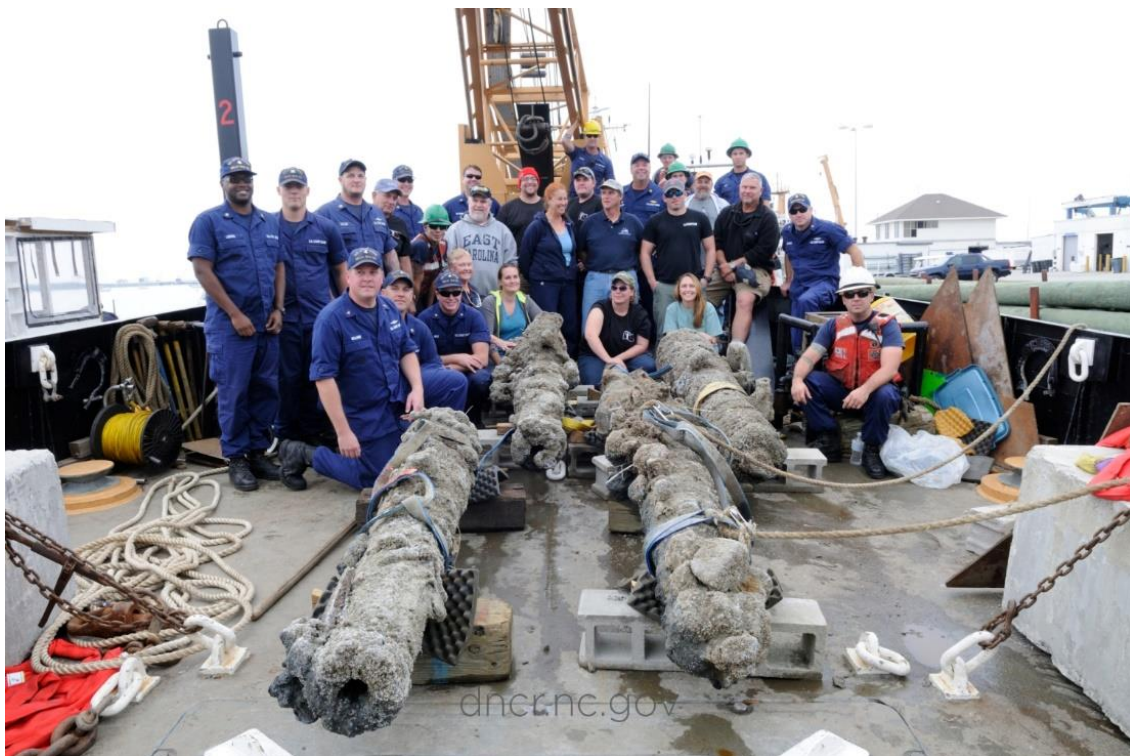
Fig. 2 Cannon aboard *Smilax* with USCG and QAR team. (Image by NC Department of Natural and Cultural Resources, 2013.)

The United States Coast Guard (USCG) Station Fort Macon near Atlantic Beach, NC served as the base for the 2013 field season. Diving was conducted from R/V *Jones Bay*, a work barge on loan from the North Carolina Department of Environmental Quality – Division of Marine Fisheries (DMF). On June 20, QAR project conservators oversaw the recovery of C12 and C20 aboard R/V *Dan Moore* from Cape Fear Community College, and USCG Cutter *Smilax* provided extensive logistical support during the second field period (Fig. 2). On October 23, under the command of Chief Warrant Officer 4 Scott McAloon, the crew of *Smilax* lifted five cannon and two cask hoop concretions, with QAR conservators aboard to ensure the safety of the artifacts.

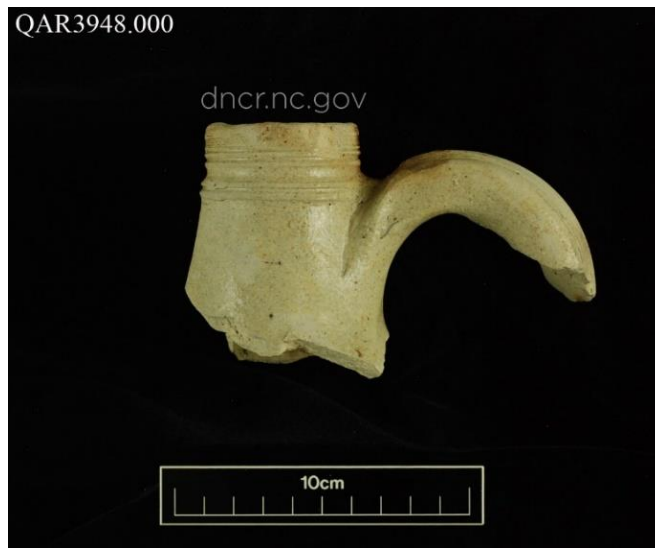
Fig. 3 Salt-glazed stoneware jug partial. (Image by NC Department of Natural and Cultural Resources, 2015.)

Artifacts recovered in 2013 include: nine cannon, two large cask hoop concretions, 354 other unique artifact numbers (termed “QAR numbers”), and 15 buckets of dredge spoil to process (Kenyon and Daniel 2013). Notable finds from the season included a salt-glazed stoneware jug neck and partial handle (Fig. 3), a copper alloy serpentine side plate which would have secured the gunlock to a musket, and a copper alloy powder ladle (Fig. 4).

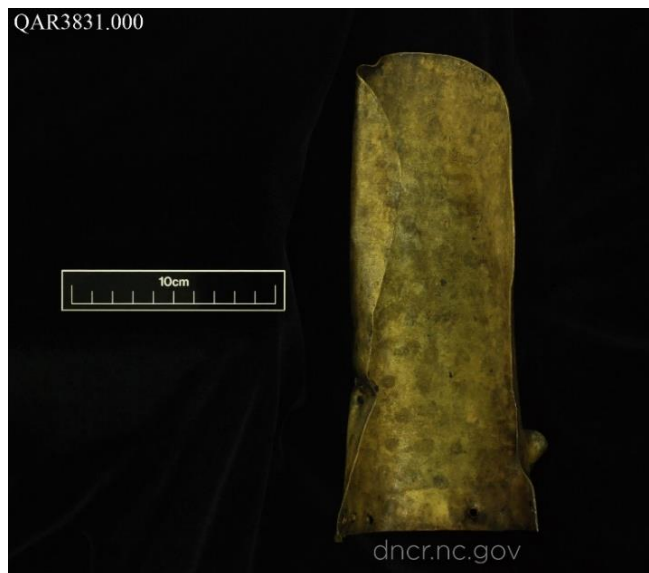
Fig. 4 Copper alloy powder ladle. (Image by NC Department of Natural and Cultural Resources, 2015.)

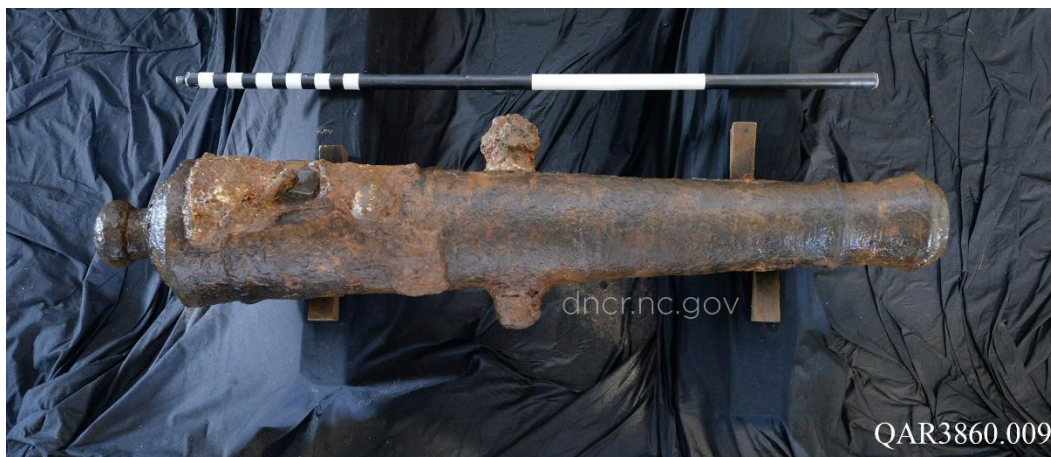
Fig. 6 Cannon C29, partially cleaned. (Image by NC Department of Natural and Cultural Resources, 2016.)

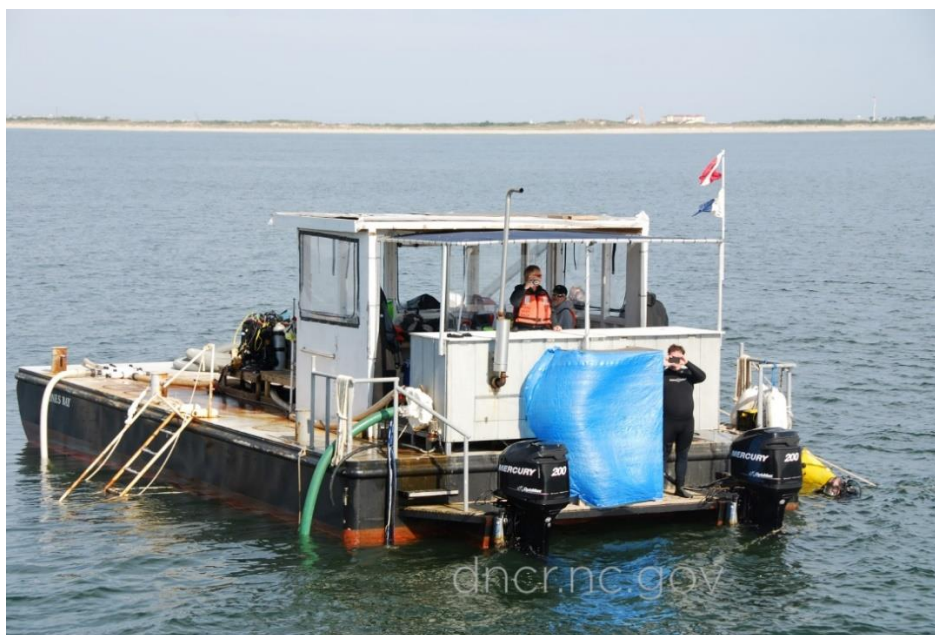
Fig. 7 R/V *Jones Bay*. (Image by NC Department of Natural and Cultural Resources, 2013.)

Improving efficiency was a key component in preseason planning, with changes to equipment design implemented in advance of the season start date. The dive platform, R/V *Jones Bay*, is a 40-foot by 20-foot open barge (Fig. 7), capable of supporting eight divers and topside crew and housing all dive and excavation equipment. With limited deck space, it was imperative that equipment be compact and lightweight, while still capable of accomplishing required tasks. Equipment was examined for improvements, redesigned, and rebuilt if necessary, to increase deck space and improve maneuverability in the water.

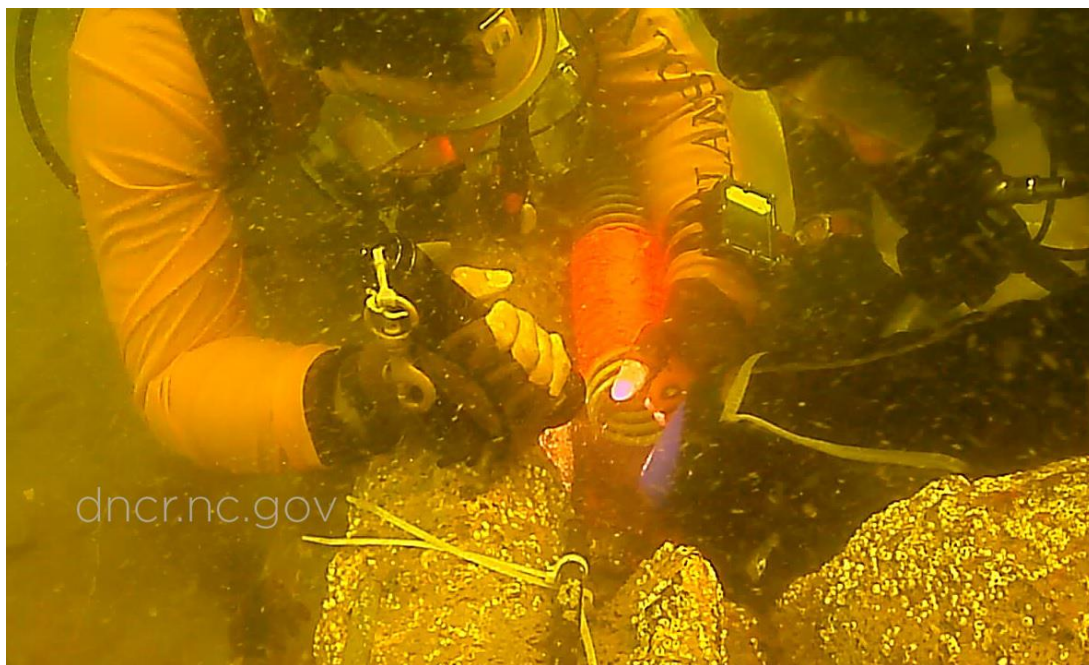
Fig. 8 Jeremy Borrelli (left) and Greg Stratton (right) chiseling between A2 and C28. (Image by NC Department of Natural and Cultural Resources, 2015.)

Following the collection of raw data for *in situ* monitoring, attention was turned to disassembling the midships concretion matrix containing at least four cannon and one anchor. Based on finds in previous seasons, other artifacts were anticipated within the matrix. Following on-site testing in 2013, the systematic de-concretion of this mass using pneumatic chisels was perfected during the short 2014 field season, which culminated in the careful removal and recovery of cannon C29. Teams of three divers were ideal for this painstaking procedure. One diver operated the chisel, a second focused a dive light on the work area, while a third employed a three-inch dredge to keep the water column free of debris and improve water clarity (Fig. 8). On days of poor visibility (less

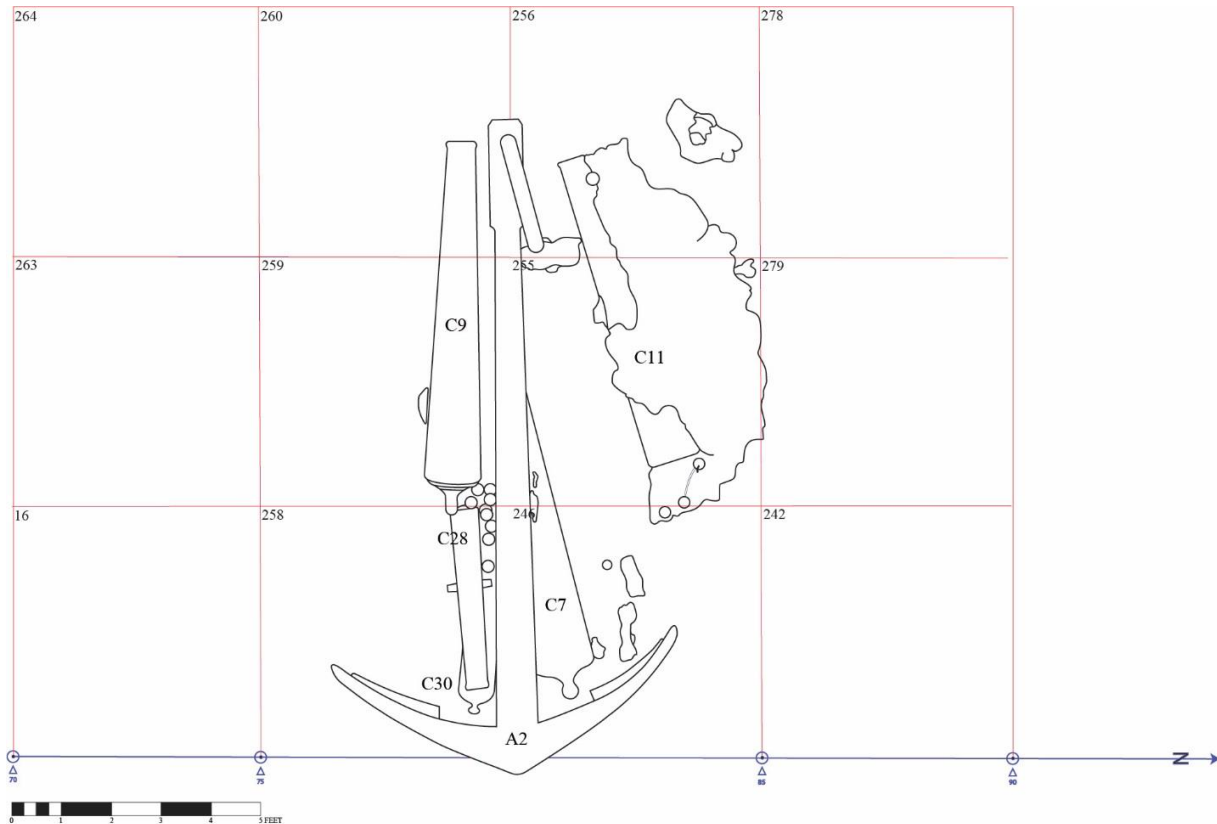
Fig. 9 The midships concretion matrix consisting of A2, C7, C9, C28, and C30. Note the cluster of cannon shot found between C28 and A2. (Map by NC Department of Natural and Cultural Resources, 2015.)

As work continued with a focus on the removal of C28, dozens of artifacts were found within the concretion matrix. Each was individually mapped and numbered prior to being dislodged. Divers were required to record in detail all artifacts tagged, mapped, and raised. As part of the daily dive log, the work area was drawn, with important features and artifacts labeled. The logs included measurements and mapping data for everything uncovered within the concretion matrix and the surrounding area. At the end of each workday, artifact mapping data was transposed onto a site map encompassing only the area immediately surrounding the midships concretion matrix, at a scale of 1:10 (Fig. 9).

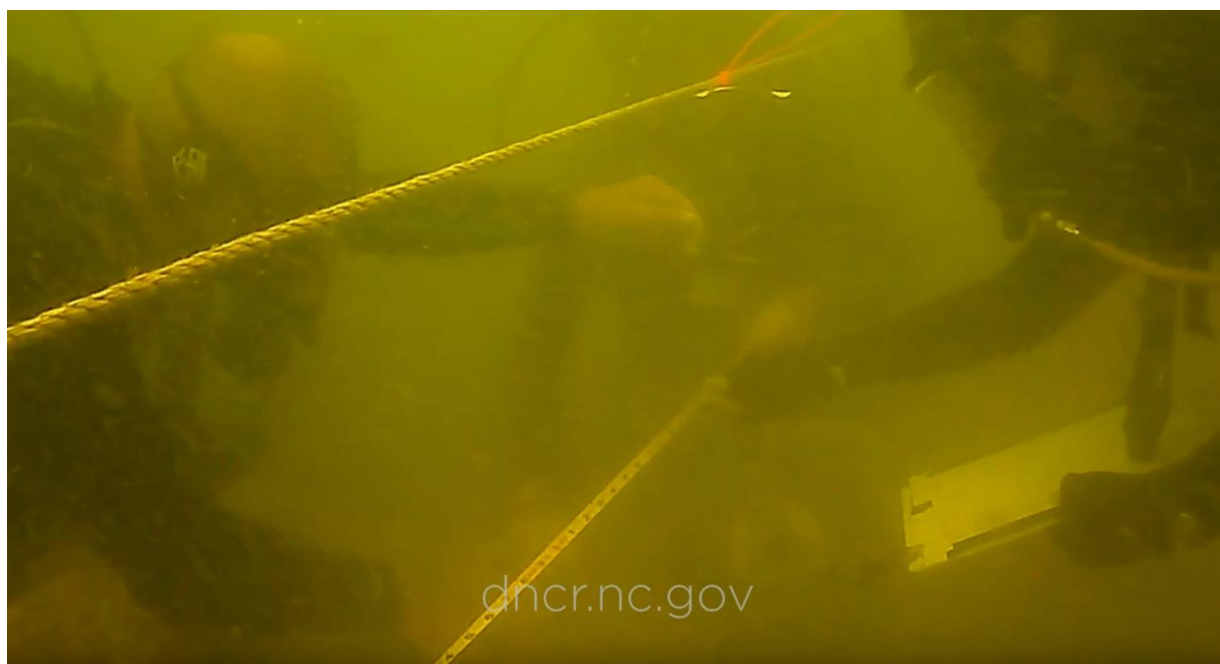
Fig. 10 John W. Morris III, Greg Stratton, and Kimberly Kenyon (left to right), mapping the north fluke of anchor A2. (Image by NC Department of Natural and Cultural Resources, 2015.)

the primary baseline. While working on a discrete assemblage within a unit, such as the cluster of objects surrounding A2, a secondary baseline was used to take direct line offsets over shorter distances. These techniques were implemented to verify each artifact's positioning prior to recovery (Fig. 10). Additionally, artifact provenience was previously recorded to the nearest three inches; this season marked the start of recording to the nearest one-eighth inch, in an effort to improve mapping precision.

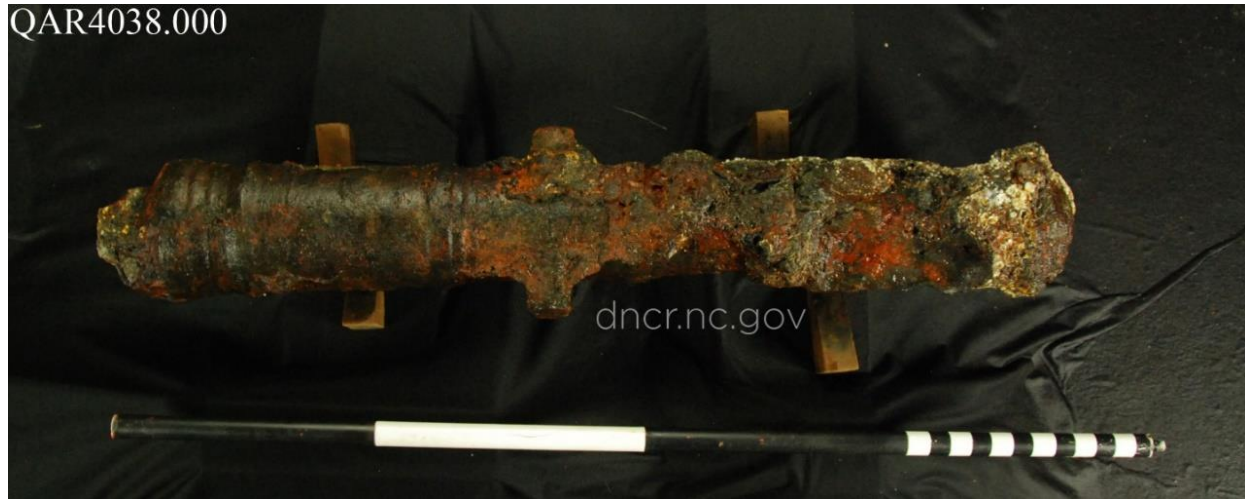
Fig. 11 Cannon C28. (Image by NC Department of Natural and Cultural Resources, 2015.)

One cannon (Fig. 11) and 28 other QAR numbers, including one bucket of dredge spoil per unit from Units 246, 255, 256, 258, 259, and 260 were recovered. Of note were ten cannon shot removed from the concretion surrounding C28, adding to the ten cannon shot recovered in the same area in 2014. The sizes of cannon shot (Henry 2011) recovered in 2015 include one 4-pounder and nine saker/6-pounder shot, compared to one 4-pounder, five saker/6-pounder, and two 6-pounder shot recovered in 2014. Two cannon shot from 2014 remain unidentified. Sediment from the six units listed above has produced an array of artifacts including: pipe stems, animal bone, brick fragments, gunflints, animal hair, a lid for a nesting weight set, a button,

Processing of sluiced material from the de-concretion of C28 produced 57 small wood fragments and 6.0 kg of concretion debitage. Also found during sifting were 13 small lead pellets resembling Rupert-method lead shot. However, it was noted that one diver's soft weight ruptured on deck, and some lead pellets made it to the site to rest directly atop C28. Since no lead corrosion or superficial iron concretion was observed, it is more likely that the pellets found in the sluice belong to the latter category instead of having been within the C28 concretion matrix. The sluiced and sieved debitage was x-rayed to identify obscured objects: two additional lead pellets were observed, which were likely missed during sieving, but no other objects were noted. Further microscopic exploration of the finer silts yielded no other artifacts. Microscopically, the silt debris looked to be nothing more than heavily iron-stained grains of lightweight sand.
